# FOCUSED SITE INSPECTION PRIORITIZATION SITE EVALUATION REPORT

TARACORP INDUSTRIES
MCCOOK PLANT
7753 WEST 47TH STREET
McCOOK, ILLINOIS

Date Prepared: August 31, 1995

Prepared by: Ecology and Environment, Inc.

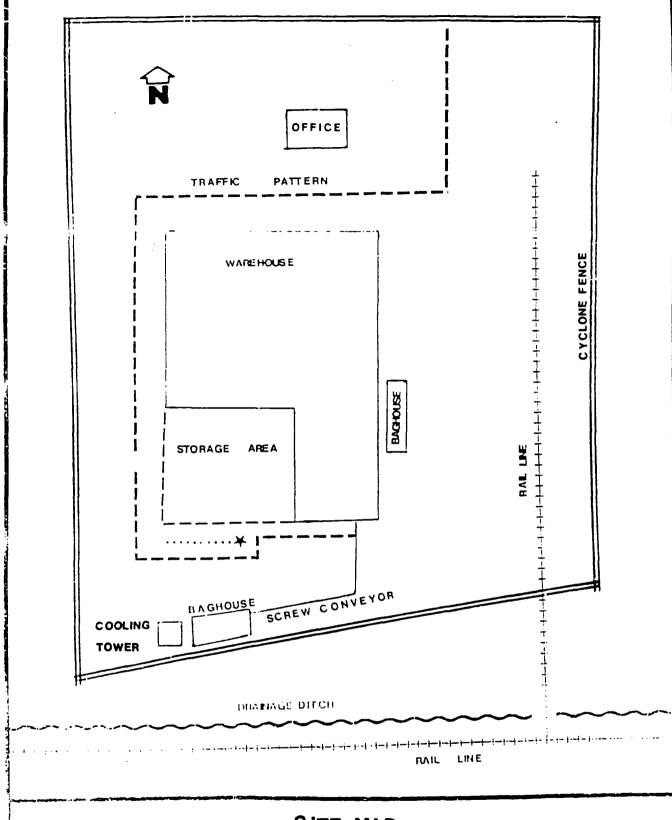
FIGURE 2

The site borders were enclosed by an eight-foot high cyclone fence with salvage yards adjacent to the property on the east and west borders. The southern perimeter is bordered by railroad tracks with a drainage ditch flowing between the railroad tracks and the fenced perimeter. The drainage ditch discharges into the Des Plaines River approximately 1/2 mile from the site. A vacant lot is located between the northern perimeter of the site and 47th Street (Figure 2).

The concrete pad used for storing lead contaminated material measured approximately 85 feet x 75 feet and was covered by a roof. Walls protected the area on the north and east sides, but no walls were present on the south and west sides (Photograph 1). The concrete on the storage pad was cracked. Dust was also found on the storage pad.

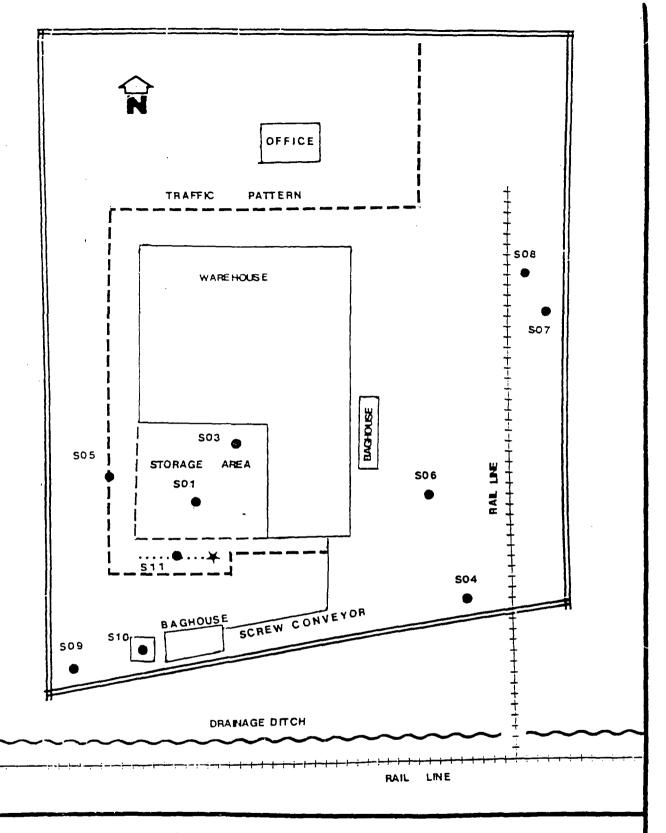
FIGURE 3

Soil samples were collected at locations listed in Table 1 and shown in Figure 3 and analyzed for total metals. Samples SO1 and SO4 were also analyzed for EP toxicity metals.
